U. S. AIR FORCE

INTEGRATED CULTURAL RESOURCES MANAGEMENT PLAN

March Air Reserve Base

January 2020

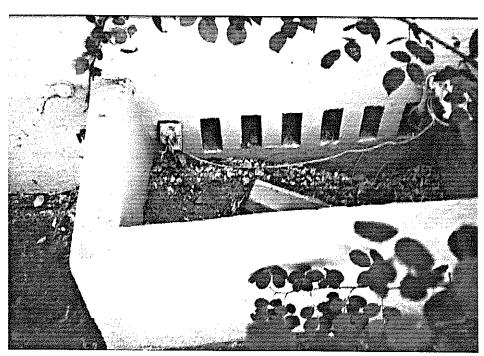
4.8 Concrete dam over foundation vent holes. This solution is less intrusive than vertical concrete boxes, see photograph of Building 215.

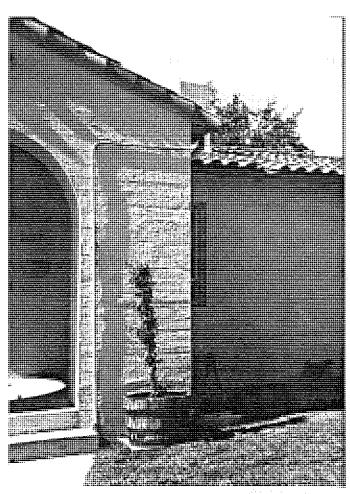
4.21 The exterior conduit pierces the eaves rather than the gable end vent, a better (but not perfect) solution.

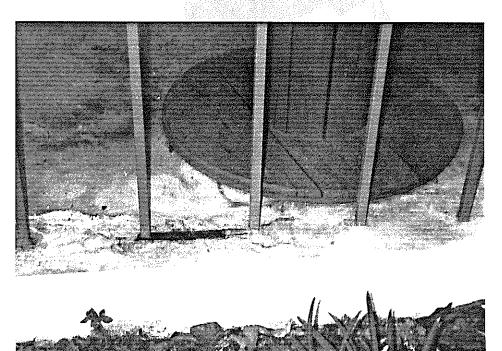
4.32 Typical rusted railing and spalling concrete on front porch, NCO Type C.

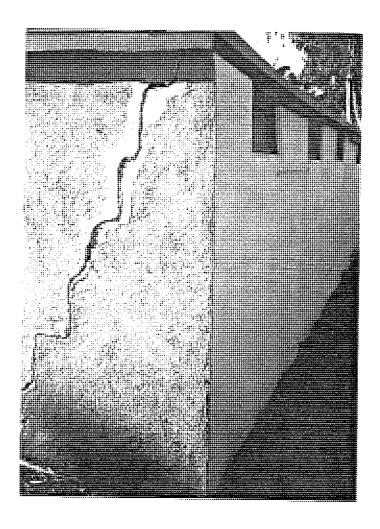
5.4 Crack in east wall (Building 113).

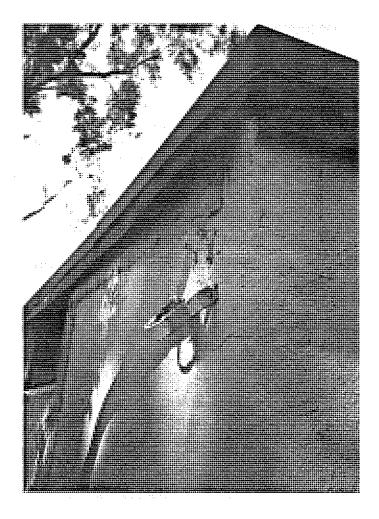
5.8 Damaged trim and missing downspout (Building 175).

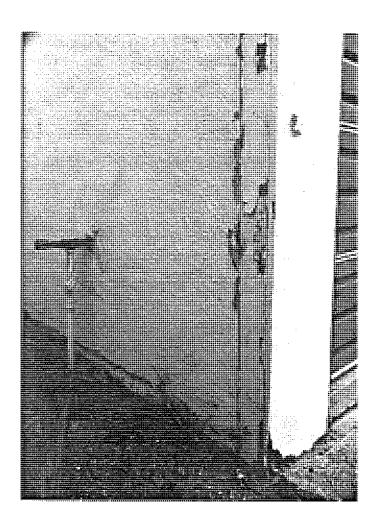
5.11 Effects of moisture penetration (Building 255).

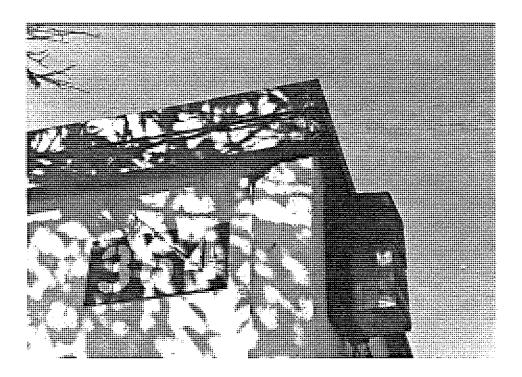
5.13 Moisture damage at upper front corner.

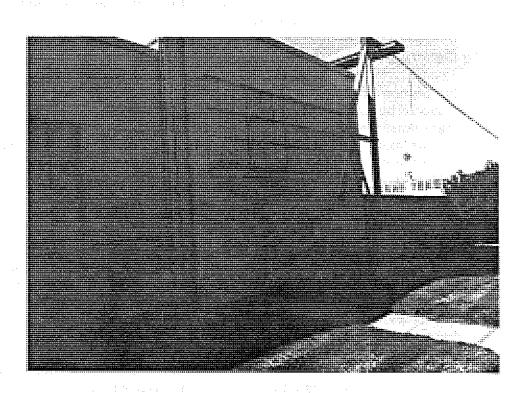
6.12 Painted out original industrial sash (Building 385).

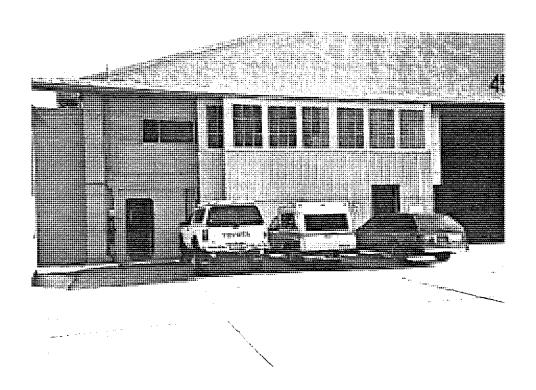
6.18 Inappropriate second story window on northwest elevation.

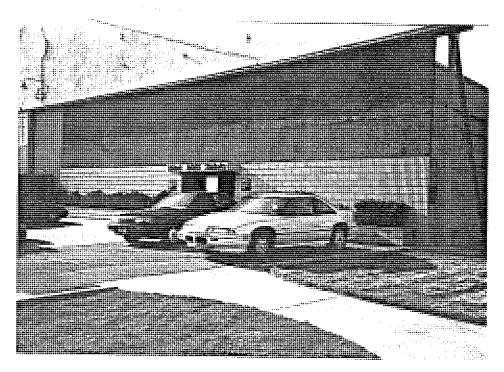
6.21 Concrete block and plywood panel replacement for hangar door (Building 457).

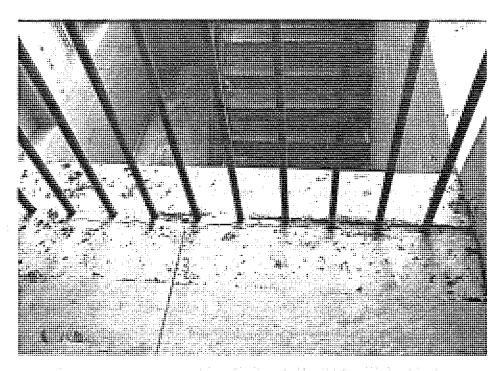
7.6 Rusted railings at rear porch.

Because of the problems inherent in their design and installation, the wrought iron railings merit frequent inspection, repair, and perhaps ultimate replacement. See General Discussion on this matter, elsewhere in this manual.

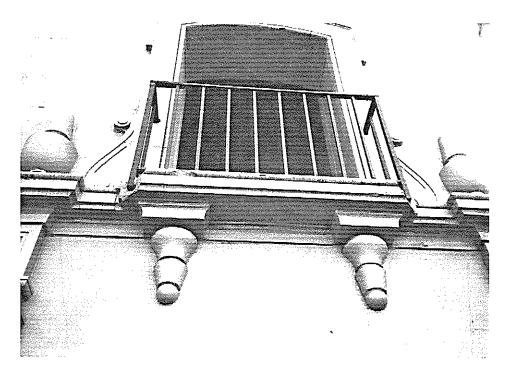
7.8 Deteriorating railing anchor at second story rear porch.

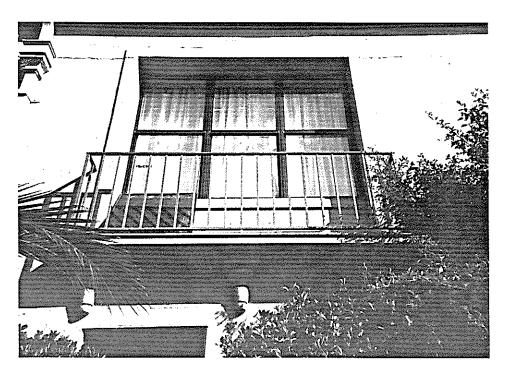
7.9 Replacement aluminum double-hung windows with missing screens

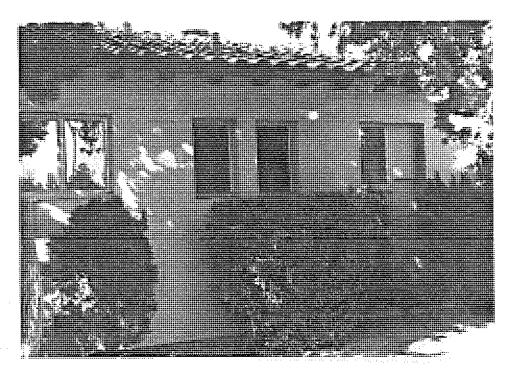
9.7 Replacement and blocked-out windows.

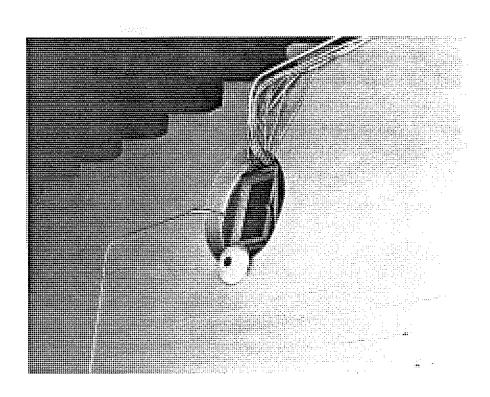
9.8 Electrical wiring in attic vents.

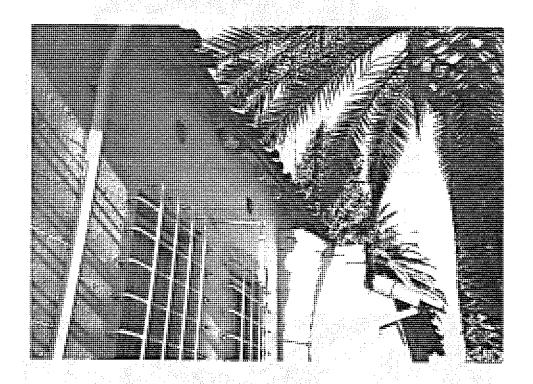
9.15 View of missing tiles and crushed gutter.

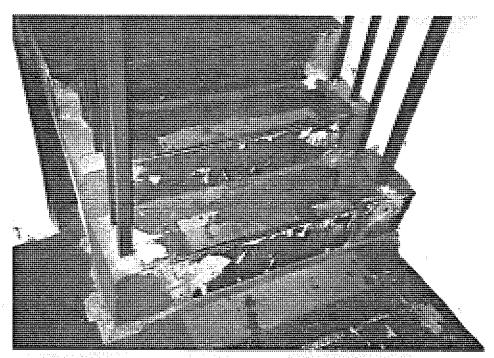
9.42 Concrete spalling on stairs.

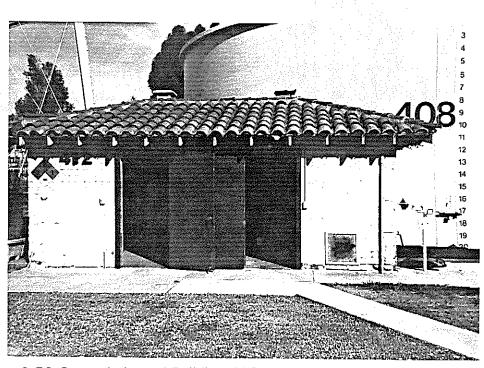
9.52 General view of Building 412, showing replacement doors.

The replacement of the existing "slab" doors with a stile and rail door more sympathetic with the character of the walls and windows, should be a long-term aim. Enough original doors still exist in the district to be able to select an appropriate design for a future replacement.

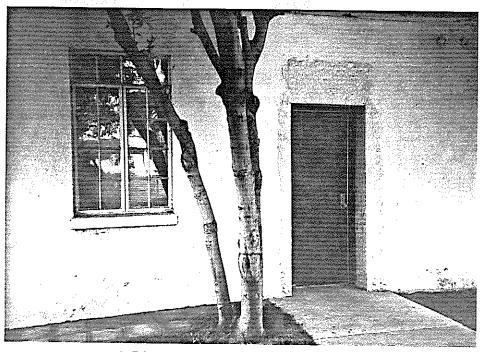
9.59 New door with unsightly patch.

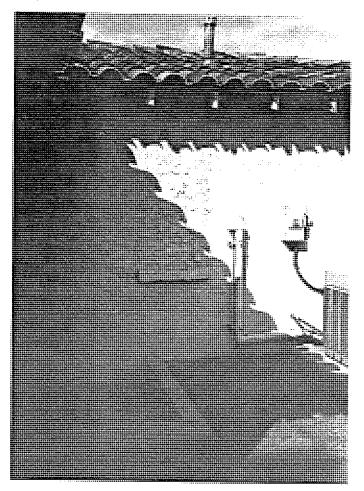
9.63 Infilled window with flush patch.

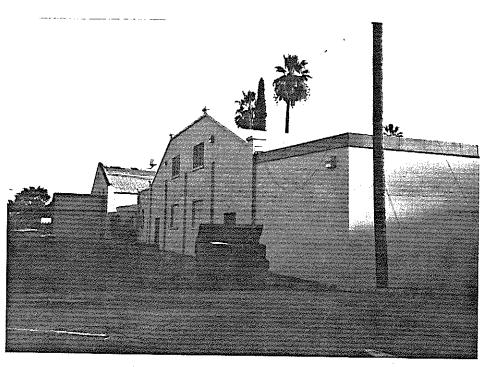
9.71 Major addition to northeast side.

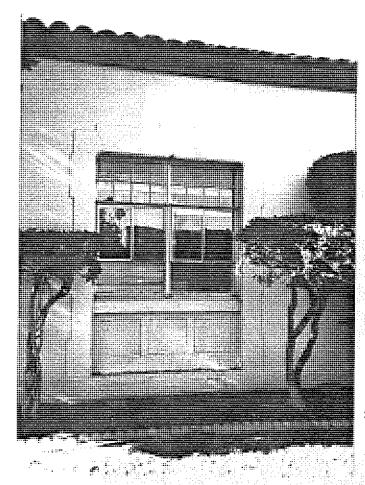
9.80 Inappropriate replacement windows.

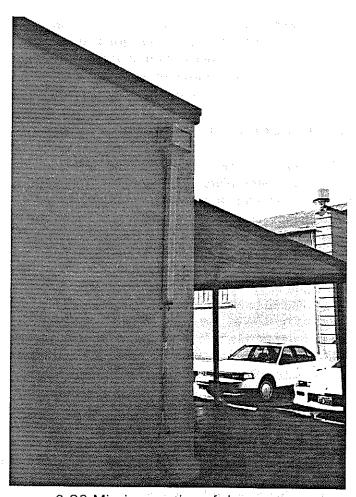
9.82 Missing section of downspout.

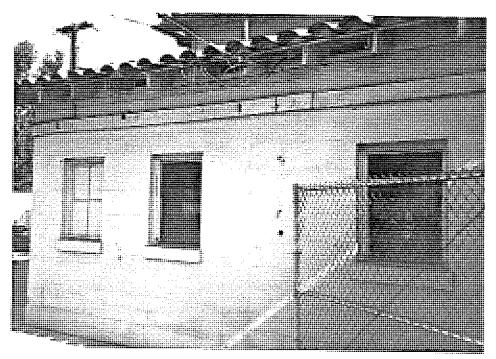
9.97 Inappropriate plastic replacement windows.

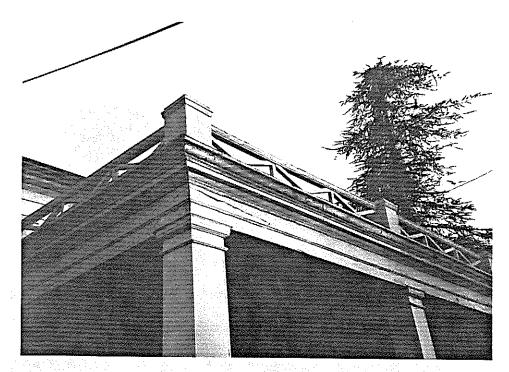
11.2 Deteriorated trim at facade.
