U. S. AIR FORCE

INTEGRATED CULTURAL RESOURCES MANAGEMENT PLAN

March Air Reserve Base

January 2020

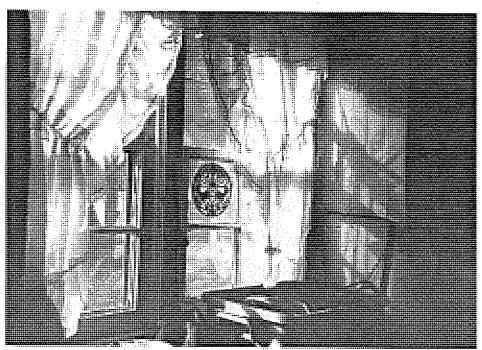
3.24 Wooden windows in back porch; these are not original, but are quite old.

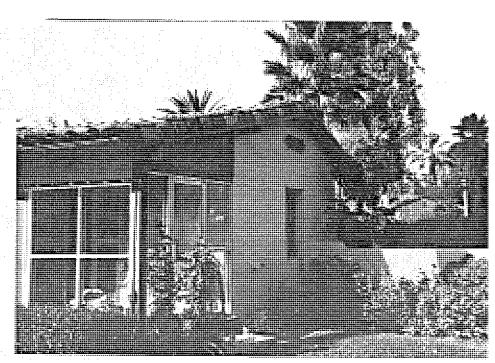
3.71 Inner courtyard, showing non-contributing enclosure and contributing half-round vents and vigas.

- 1. Return kitchen and bath ceiling to full height as acoustical tile ceilings deteriorate.
- 2. Restoration of hardwood floors as carpeting or parquet flooring deteriorate.
- 3. In the very long term, the base might consider removing the patio enclosure. This would be quite difficult to accomplish, however, because the enclosure is not lop-sided, with the walling in of the patio to the right and construction of the rear guest room. The purpose of removing the enclosure would be to restore the intended "indoor-outdoor" feeling to the patio and it is unlikely that feeling could be restored adequately, owing to major structural additions.

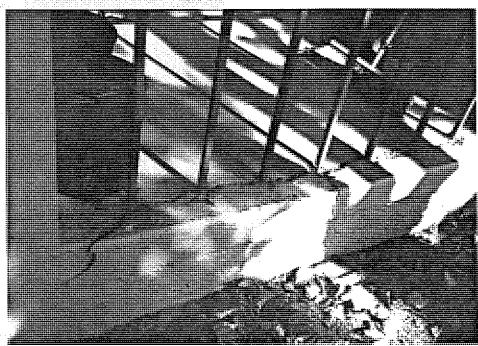
Repair rusted front rails, spalling concrete on porches: These front railings occur only on NCO types B and C. These railings were installed with a horizontal bar embedded just below the surface of the concrete. If the rails are allowed to rust, the rust expands to that horizontal bar, causing discoloration and ultimately to spalling of the concrete.

4.16 Rusted rails and spalled concrete at front porch NCO Type B.

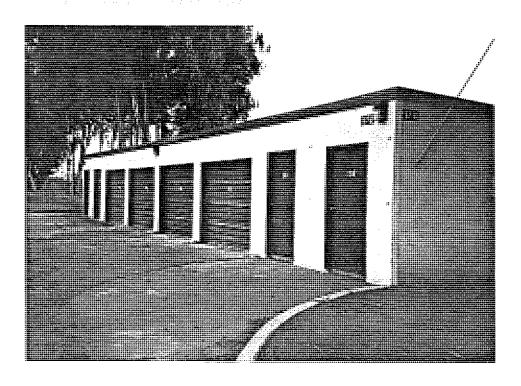
5.10 Six car garage converted into garage/storage building.

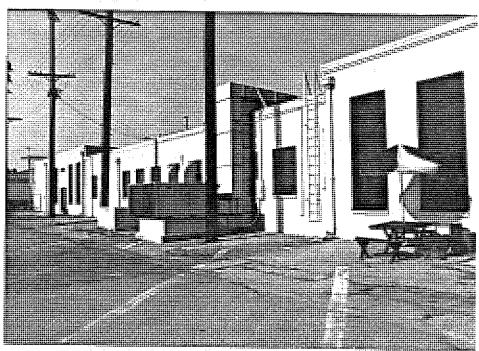
The total loss of the original windows is a negative impact of major proportions. The ultimate goal for this building should be the restoration of the original, strongly character-defining windows.

6.6 Muntin-less smoked glass replacement windows.

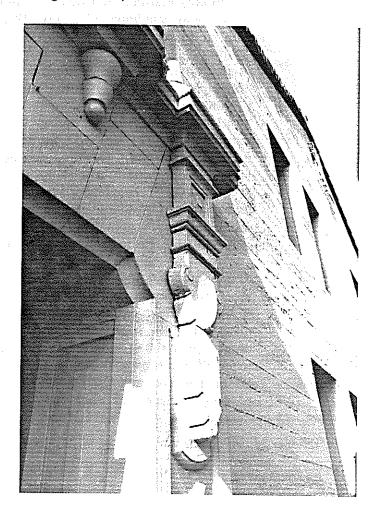
7.7 Painted ornamental terra cotta tile.

The paint should be removed from the terra cotta ornamental work on the building, and repairs made to the surfaces and, if necessary, to the anchorages (Photograph 7.6). Significant reconstructive work is needed at the second floor balcony at the Loggia's terminus. Perhaps this could be done with glass fiber reinforced concrete or with a similar substitute material. Whatever the solution, it is important to recapture the original appearance of this important feature of the building. In addition, the careless overspray of paint onto the Mission tilesespecially at the entrance buttresses—should be removed.

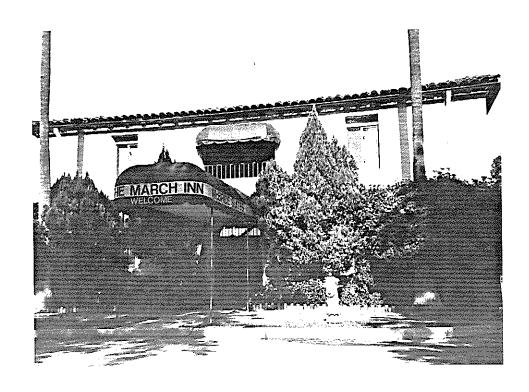
9.10 Facade, showing awning and aluminum sash.

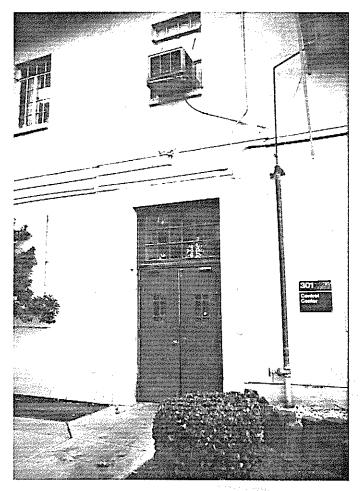
9.22 Original doors.

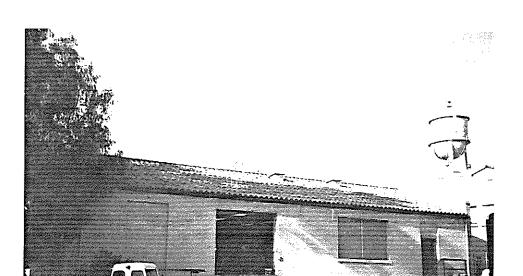
Building: 433

General Condition: The general condition of the building is good. Like many other buildings, the only apparent problems are with the gutters.

9.68 General view, southeast elevation, 1993.

Quartermaster documents show a photograph of the southeast elevation. This should provide guidance for any future modifications to doors and windows. The windows were center pivoting steel industrial sash with a row of fixed-lights at the top and bottom. The doors were nine-light over one panel doors with a transom above. Future plans for the building should consider the removal of the addition to the northwest, space requirements permitting.

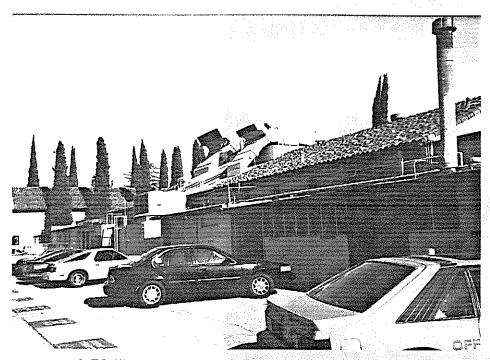
There is evidence of long-term leakage problems. This is not unusual in situations where a building was constructed in segments, and in situations where a great deal of equipment is on the roof. This building suffers both, requiring frequent and thorough inspections.

9.78 Flat roof addition and roof mounted equipment.

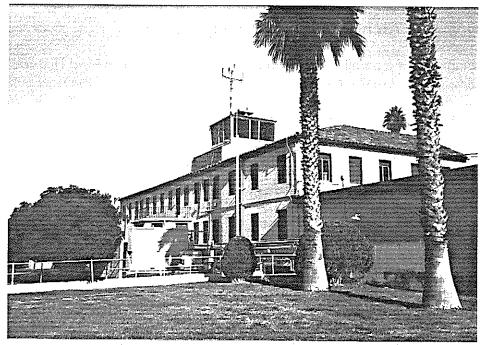
9.91 Infill of second story windows on flightline.
